Geomorphological Accidents caused by the Tokachi-oki Earthquake

Kasuke NISHIMURA, Shuryo SEGAWA, Hiroshi MIZUNO,
Hosei HOTTA, Osamu MIURA, Toshikazu TAMURA
and Takekazu AKAGIRI

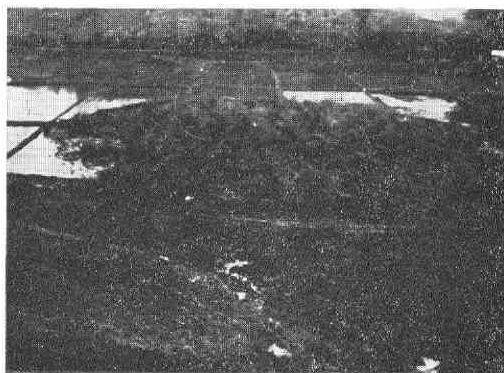
Deposition area spreads widely on lower concave slope and valley floor like a palm leaf or a tongue where the valley is wide enough (Photo. 4) and elongated downstream where it is narrow. Deposited materials on the area about 1 m in depth are consisted of smashed materials of black surface soil and dark brown subsoil with

←Photo. 4 The deposition area of the failed zone at Eifukuji (Loc. 2 in Fig. 3). See Fig. 5 also.

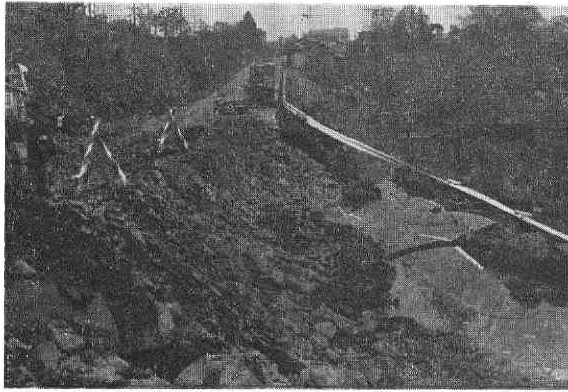
The destruction of railroads and highways at more than two hundred places in Aomori prefecture were caused by the collapses of artificial embankments such as railroad basements or highway roadbeds across the dissected valleys. They were generally filled with dark-brown loamy volcanic ash (Photo. 7).

The heavy rainfall just before the earthquake had prepared the collapses of embankments, that is, the heavy rainfall above 160 mm in three days made the embankments fragile, and the earthquake itself was no more than the motivation of collapses.

Photo. 7 Roadbed destruction of National Highway Rt. 104 near Kita-takaiwa

Therefore, the water-proof and earthquake-proof technology of artificial embankment will come into argument in the civil engineering works.

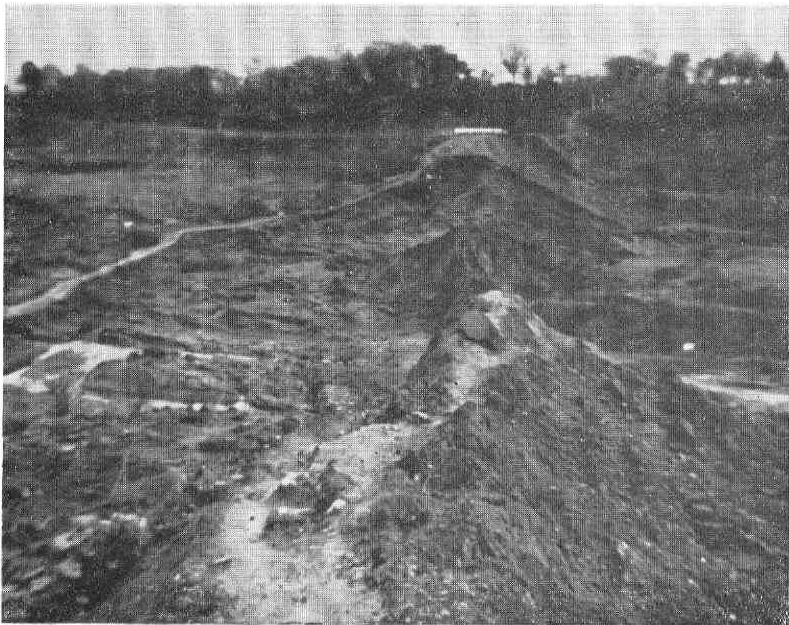
At Hayakake-numa the earthquake caused several cracks parallel to the length of the dam and broke it at two places. Total width of the breaks reached about 150 m (Photo. 8). Consequently a flood happened and it flowed with full strength eastward to the Tanabu river, and it washed away the roadbed of the Ohata line railroad (Photos. 9, 10). Then the flood flowed down southward along the Tanabu river, when the flood-flow was weakened and controlled by micro-landforms, and formed a temporary lake at the upper side of Akasaka bridge east of Mutsu city.

Causes of breaks of the dams in Shimokita district are as follows: 1) dams were made of earth and constructed over 20 years before, 2) capacity of reservoirs were large and every reservoir was filled fully with the rain water of the preceding heavy rainfall, 3) the shock of the earthquake was too strong.

Photo. 8 Dam destruction of Hayakake-numa Reservoir

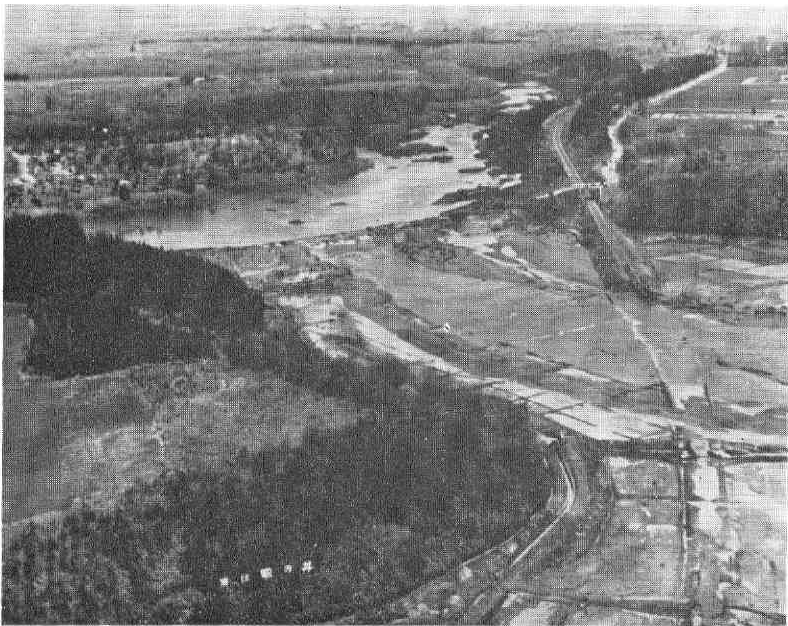
Photo. 9

Photo. 9, 10 Hayakake-numa immediately after the destruction

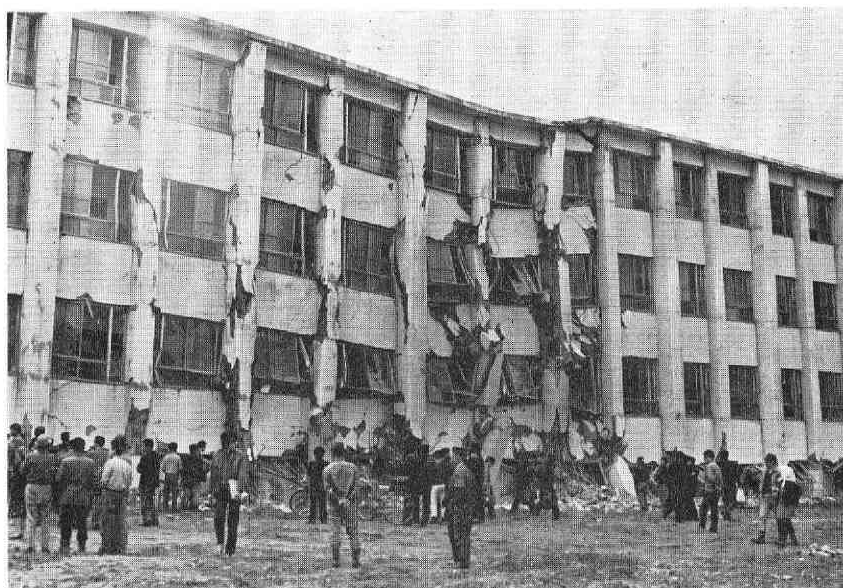
These accidents are almost always found in the land reclaimed from the sea. The collapse of the Hakodate college on the coastal terrace surface is the only exception, which is perhaps due to the architectural faults (Photo. 11)

Photo. 11 Hakodate College severely destroyed

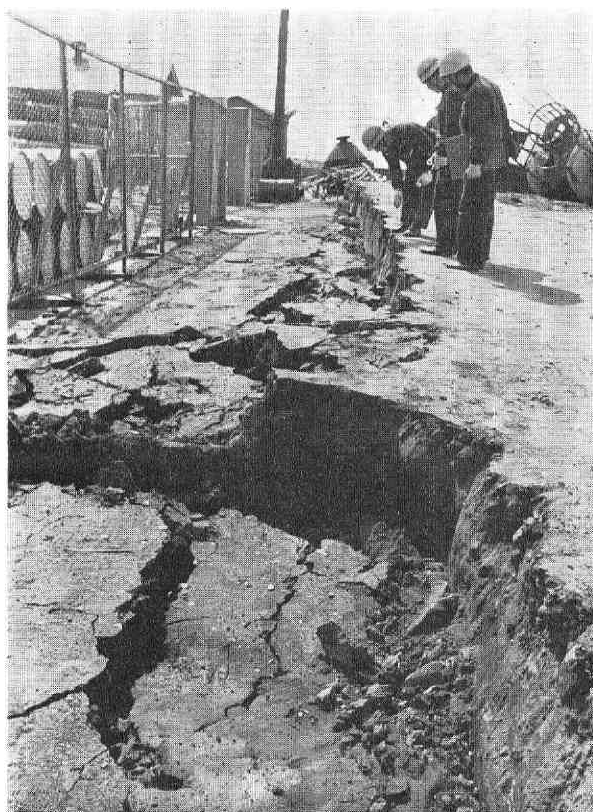
Landform dislocations caused by the Tokachi-oki earthquake in Hakodate city are classified into cracks, horizontal and vertical dislocations mainly in the reclaimed lands (Photo. 12, 13).

Photo. 12 Fissured yard, Mitsubishi Petroleum Co., Hakodate City

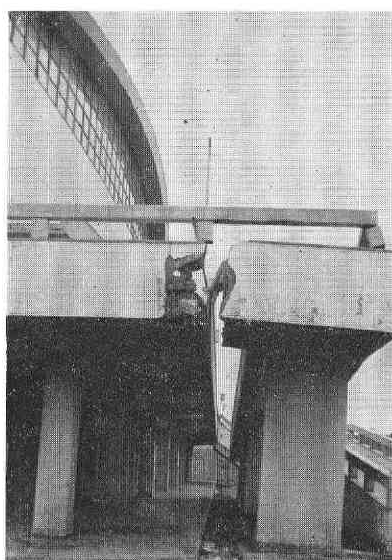
below the upland called Hachinohe terrace were damaged, for example, the municipal gymnasium (Photo. 16).

Photo. 16 Hachinohe Municipal Gymnasium

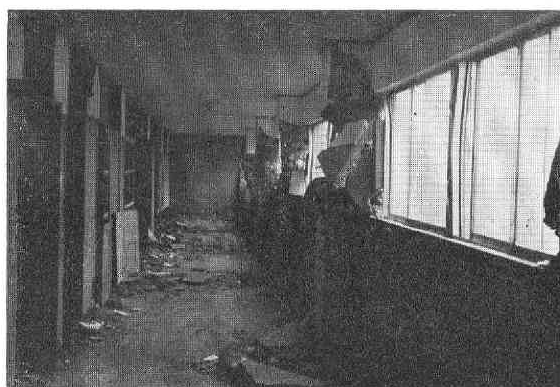
The three-storied steel-concrete building of Hachinohe Technical College on another terrace 50–53 m above sea level suffered severe destruction by the earthquake (Photo. 17). The subsurface geology of the ground of the building is almost the same as the Hachinohe terrace. Before the College was built, there had been a few open, shallow valleys cutting the terrace surface as on the Hachinohe terrace (Fig. 15). In the college campus there occurred cracks on paved road, and depressions and mud-jetting on the ground. Especially, in the first floor of the college building many parts of wall cracked, many pillars and windows broke. It is dangerous to build steel-concrete building on the very position of the above mentioned valleys buried with thick volcanic ashes which absorb water easily.

Photo. 17 Hachinohe Technical College
