Ph.D. Thesis

**Rapid Seismic Evaluation Method and Strategy for
Seismic Improvement of Existing Reinforced
Concrete Buildings in Developing Countries**

Tohoku University

September, 2019

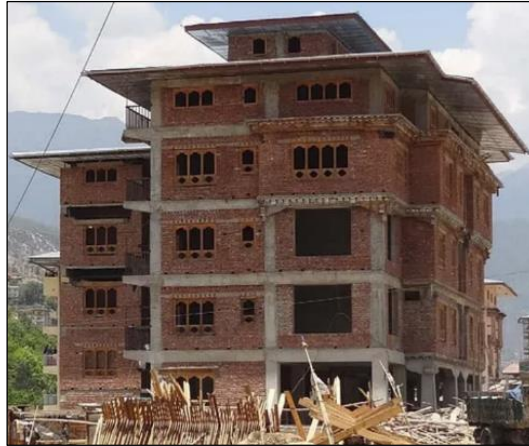
Figure 1.2 Building with Masonry infill (Photo: Janise Rodgers, Bhutan)

Reinforced concrete (RC) frame with masonry infill, such as in Figure 1.2, is a common structural system in those developing countries. Construction of this type of structure has been increasing rapidly due to very fast urbanization in major cities of those developing countries for meeting the requirement of urban inhabitants.

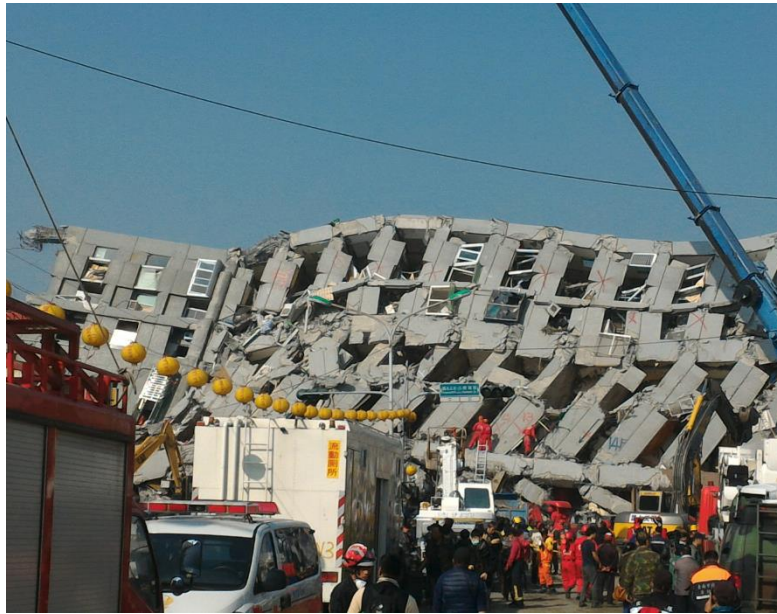
Figure 2.14 Severely damaged buildings in Taiwan earthquake (datacenterhub.org)

On 6 February 2016, an earthquake of 6.6 occurred in southern Taiwan. The epicenter is located in the Meinong District at a depth of approximately 14.6 km as shown in Figure 2.13. The earthquake caused widespread damage, resulting huge casualties. Many low rise RC buildings were collapsed due to this catastrophic earthquake. A large amount on building severely damaged in Tainan city which is near the epicenter of the earthquake as shown in Figure 2.13.

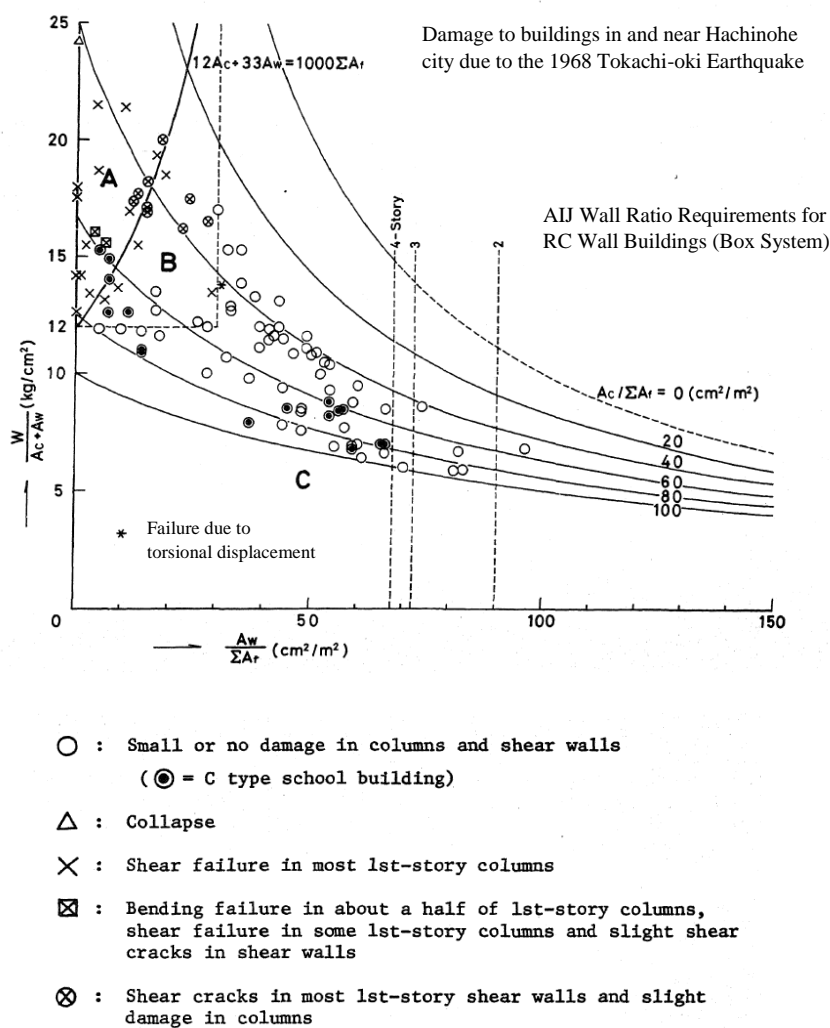
Shiga et al. (1968) proposed a practical method named as ‘Shiga Map’ as shown in Figure 2.19 to rank low-rise RC buildings according to their seismic vulnerability after investigating the damaged buildings in the 1968 Tokachi-oki earthquake, in Japan.

Figure 2.19 Shiga map (Shiga et al. 1968)

damaged buildings. However, Shiga map does not consider masonry infill wall because masonry infill wall is not common in Japan.

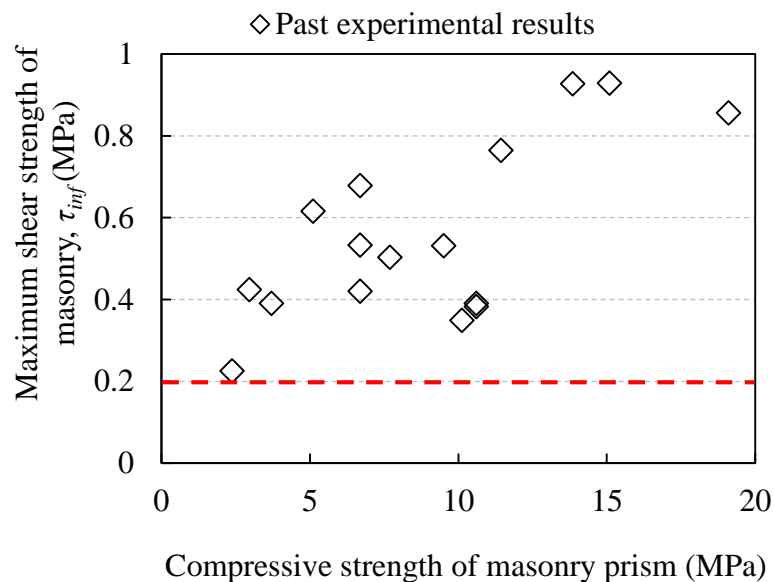
ASCE seismic guideline (ASCE/SEI 41-06 2007) prescribed 34 psi (0.24 MPa) for good masonry condition. Besides, the average lateral strength for masonry infill wall is assumed of 0.28 MPa based on past experimental studies in Nepal (Karmacharya, U 2018). Chiou et al. (2017) proposed lateral shear strength for masonry infill, after experimental verification and theoretical formulas, as 4.0 kgf/cm² (0.39 MPa) for preliminary assessment of low-rise RC Buildings in Taiwan. Figure 2.24 shows maximum shear strength of masonry infill corresponding to compressive strength of masonry prism (Alwashali, 2018). In this study, a value of shear strength of masonry infill, τ_{inf} , is considered as 0.2 MPa, which is a conservative value for masonry with compressive strength of less than 10 MPa, as shown in Figure 2.22.

Figure 2.22 Average shear strength for masonry infill with compressive strength of masonry

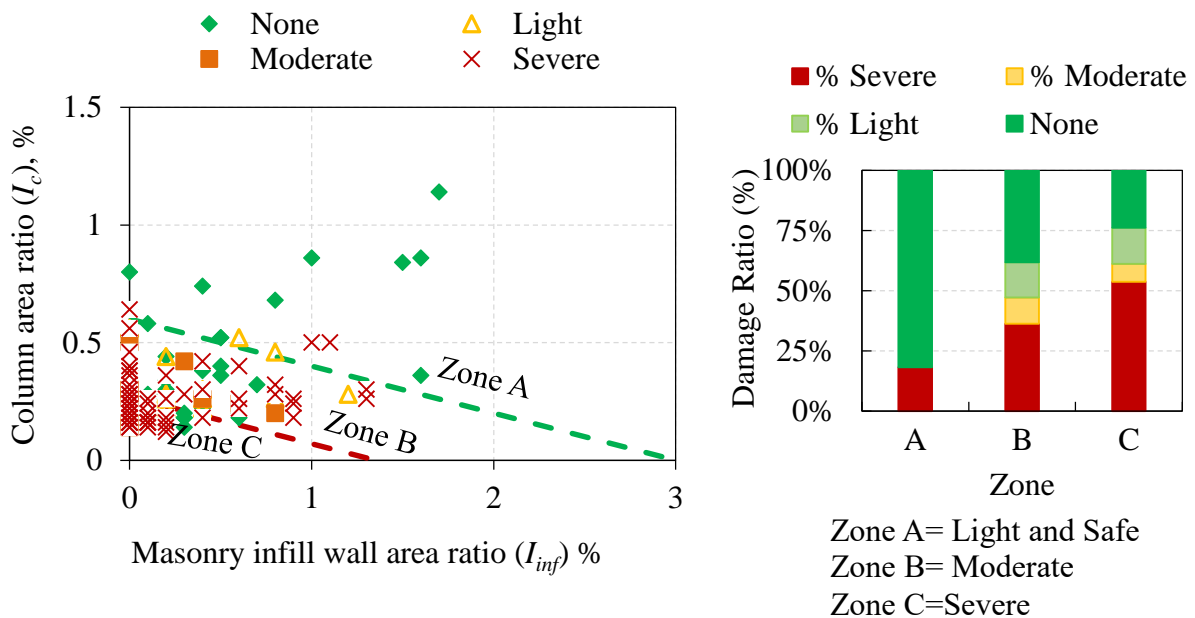
In order to study the correlation column area ratio and wall area ratio with damage state, these simple parameters have been plotted in both principle directions along with damage states as shown in Figure 2.25. The lines are drawn in the plot according to seismic demand for ground motion of the corresponding earthquake. These lines designated as upper boundary and lower boundary, defining the map into three different zones namely Zone A, Zone B and Zone C for describing light, moderate and severe respectively. Buildings placed at zone C are considered the most vulnerable and expected to have severe damage. Buildings located at zone A are considered to have enough seismic capacity to avoid severe damage.

Figure 2.25 Column area ratio and infill wall area ratio with damage state

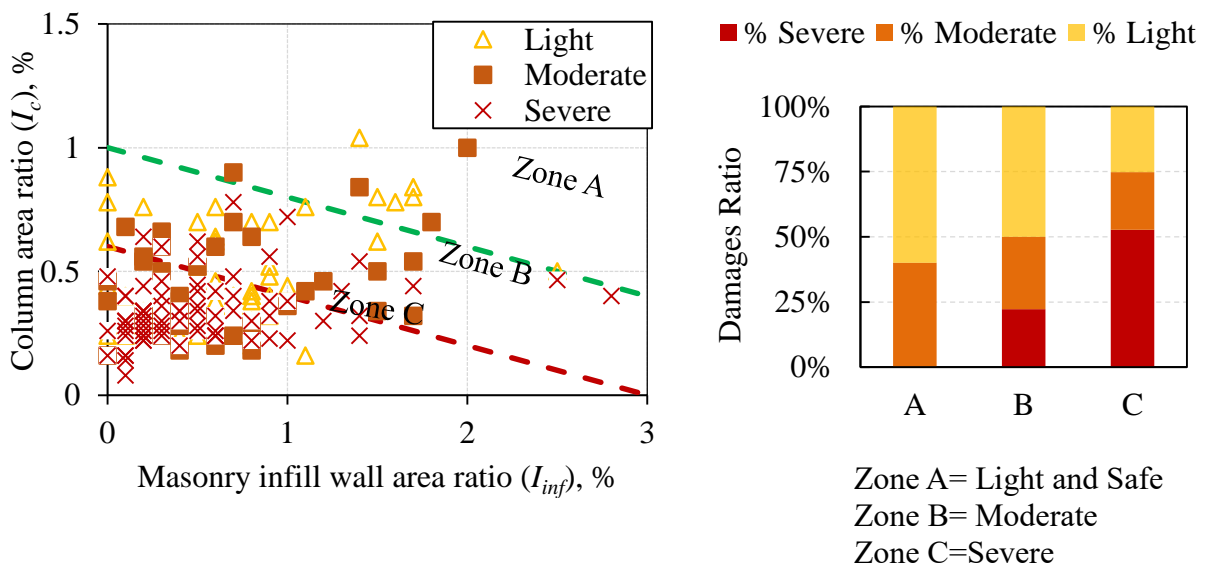
Column area ratio and wall area ratio has been plotted with damage states of the investigated buildings as shown in Figure 2.31. The boundary lines considered based on seismic demand of the earthquake divided the plots into three zone defined as A, B, and C as Light and Safe, Moderate and Sever zones, respectively. It has been observed that more than 50% of total buildings at Zone C have been identified as Severely damaged buildings. In contrast, more than 50% of total buildings located at Zone A have been recognized as light and Safe buildings according to actual damage state. It has been restated that these simple parameters can identified the most vulnerable buildings.

Figure 2.31 Column area ratio and infill wall area ratio with damage state

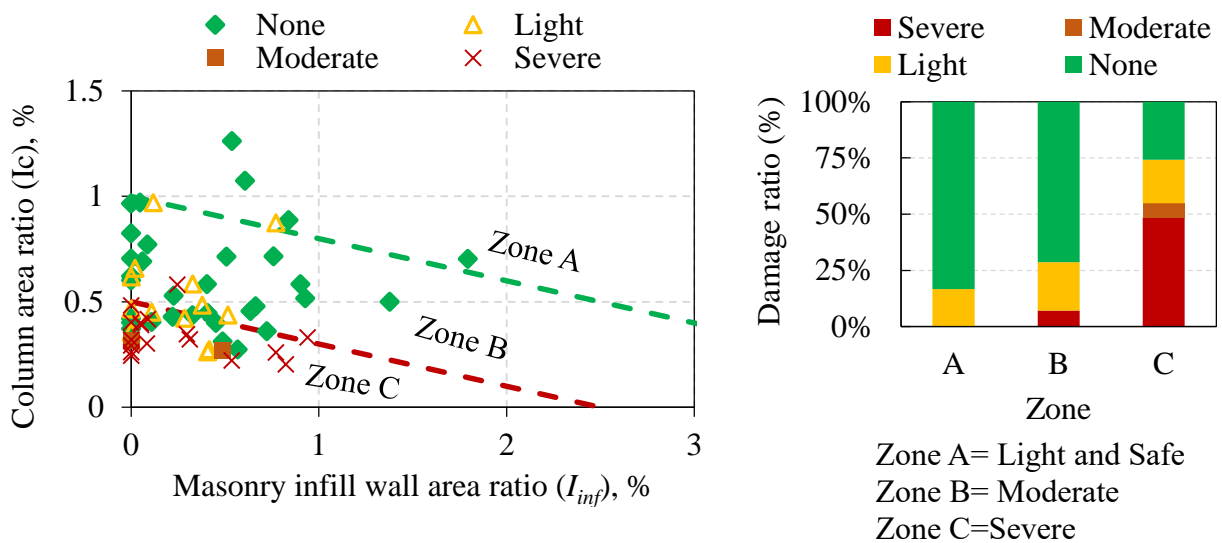
The simple parameters described in aforementioned section have been plotted as shown in Figure 2.28. The two lines has also drawn into the plot according to seismic demand of this earthquake. These lines also have divided the plots into three zones A, B and, C for describing light, moderate and severe zone respectively. From this figure it has been seen that, more than 60% buildings located at zone C are moderate to severely damaged due to this earthquake. On the other hand, 80% buildings are non-damaged buildings located at zone A. It means that these simple parameters can have good correlation with damage status.

Figure 2.28 Column area ratio and infill wall area ratio with damage state

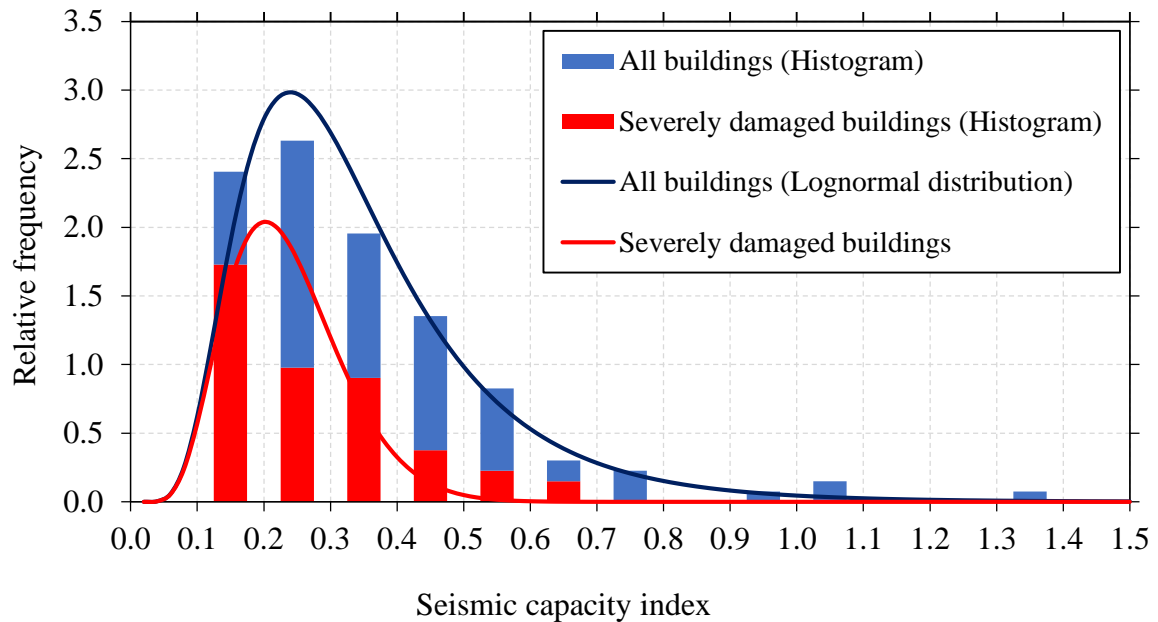
Figure 2.37 shows distribution of seismic capacity index of total investigated buildings and severely damaged buildings. It has been observed that the seismic capacity index of 0.6 includes all severely damaged buildings. However, the seismic capacity of buildings beyond the judgement criteria shows non damaged buildings.

Figure 2.37 Distribution of seismic capacity index for total buildings and damaged buildings.

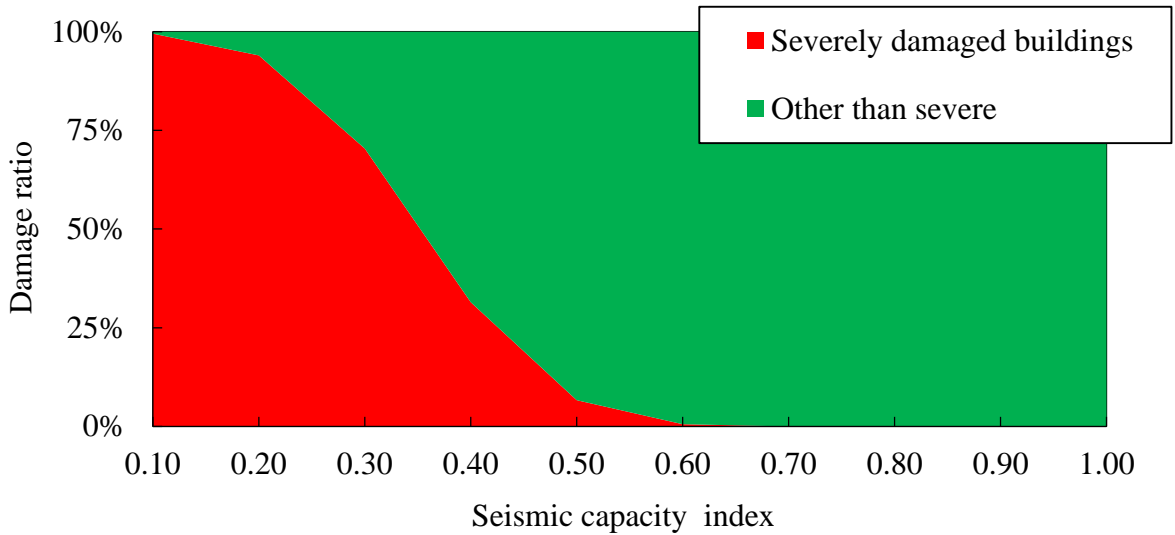
Probability of damage ratio with seismic capacity has been developed for Nepal EQ damage database. Figure 2.38 shows the correlation of damage ratio and seismic capacity index. As seen in Figure 2.38, it has been observed that the seismic capacity index is higher than 0.6 showing no severely damaged buildings. However, this boundary can be set as judgement criteria for seismic capacity investigation.

Figure 2.38 Correlation the seismic capacity with damage ratio based on investigated buildings.

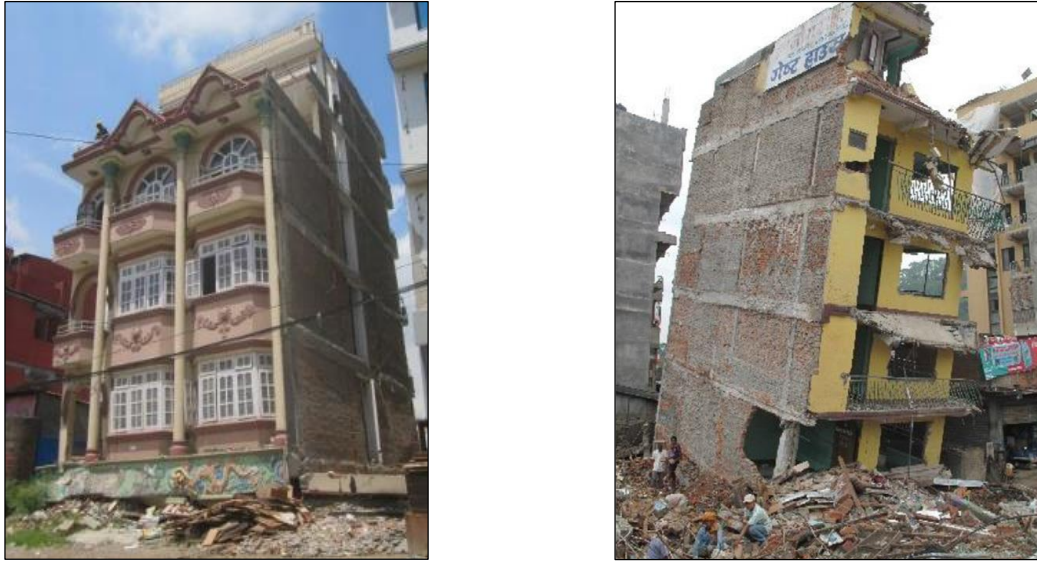
Figure 5.5 Examples of buildings subjected to soft-story collapse during the Nepal earthquake (datacenterhub.org)

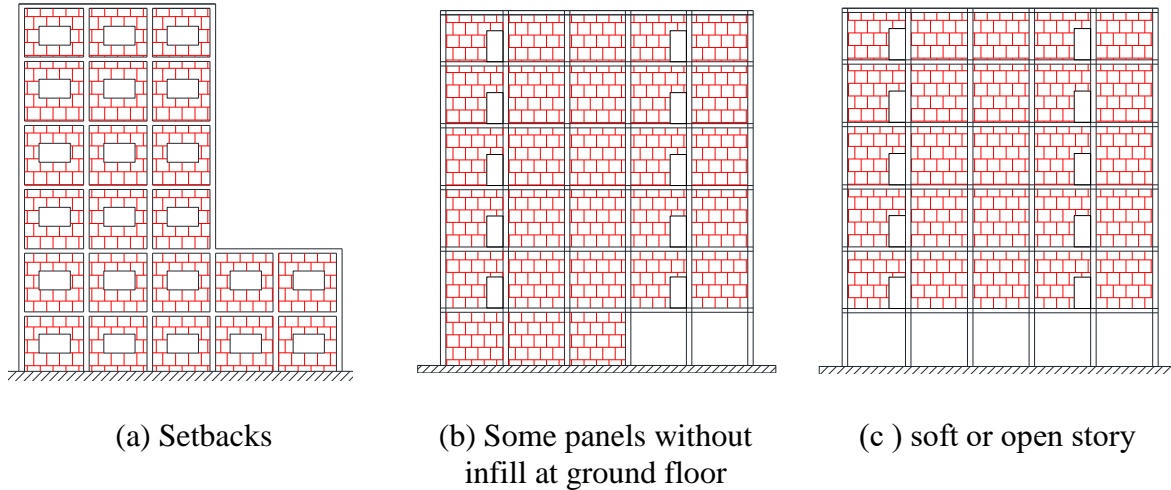
Figure 5.6: Elevation view of some typical RC frame having vertical irregularities

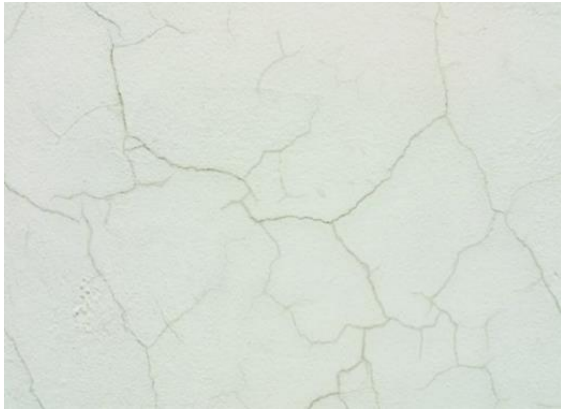
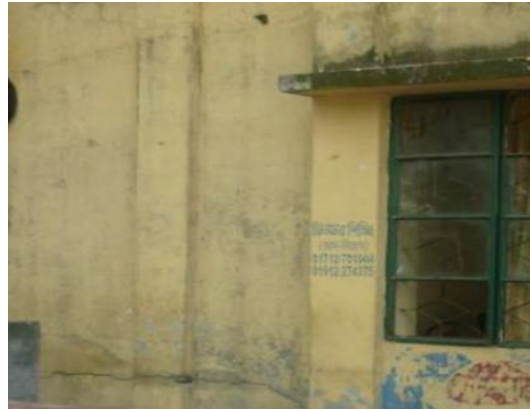
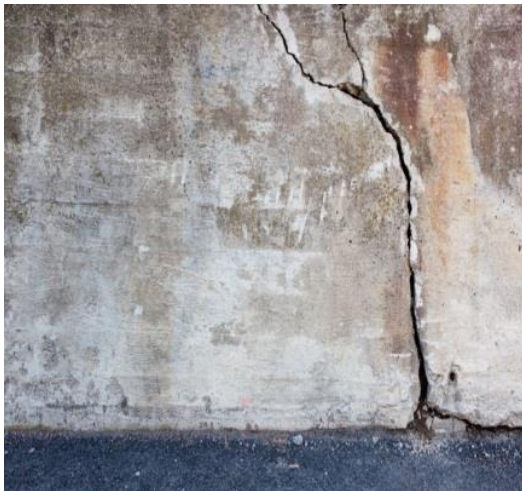
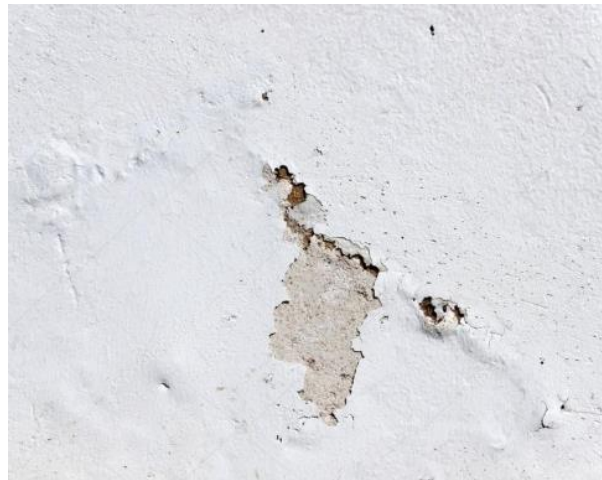
Figure 5.9 Deterioration of Concrete due to cracking

Deterioration of concrete in structural elements indicates the actual state of seismic capacity of the building. Theoretically, presence of cracks as well as spalling in concrete are responsible toward the degradation of seismic capacity. This also refers a building might be possessed weak material and poor workmanship. Furthermore, the correlation between the building quality with different damage state has been observed based on study of past earthquake damage database (Sucuoglu et al. 2007). Figure 5.9 shows typical crack exists in RC structure which can be easily identified by visual inspection.

(a) Plaster crack (do not consider)

(b) Crack through RC column (consider)

c) crack in wall (do not consider)

d) plaster deterioration (do not consider)

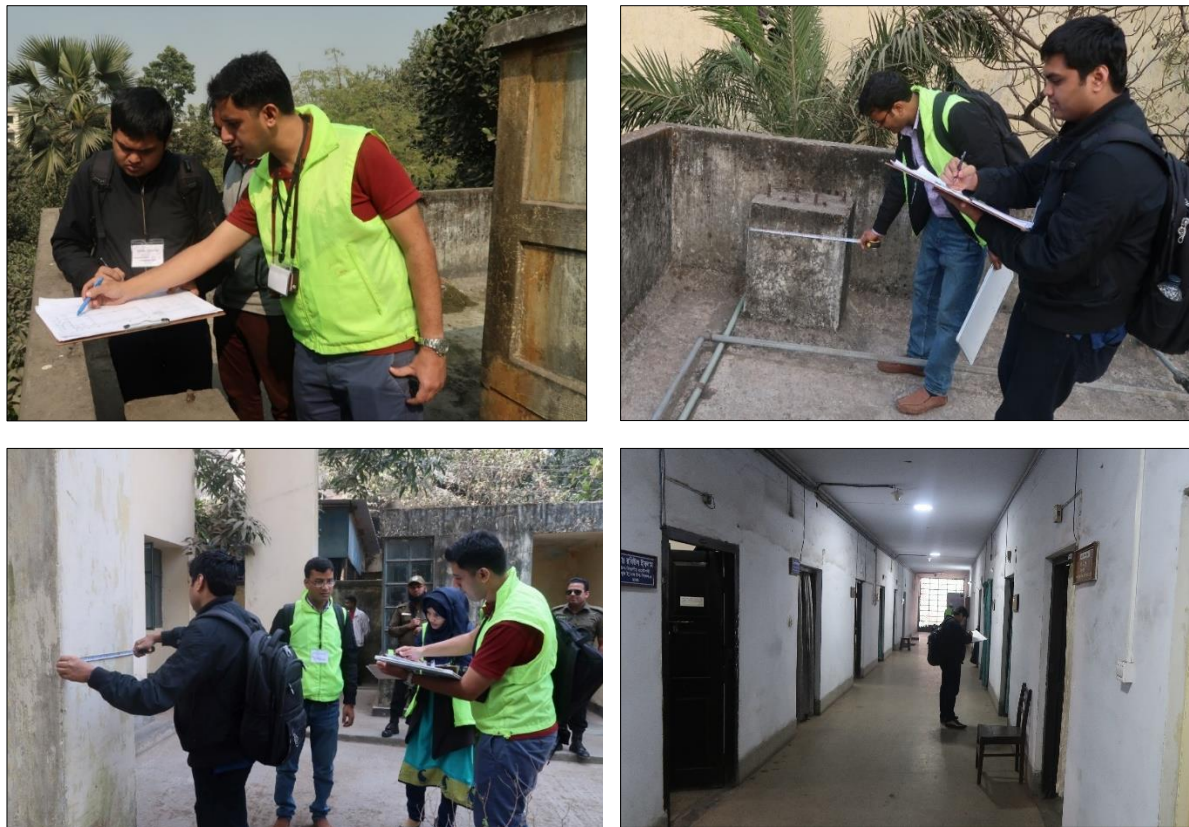
Figure 6.16 Photos of preparation of as-built drawing

As previously mentioned, all building does not have architectural drawings, therefore, as-built drawings has been prepared for all investigated buildings. As-built drawing preparation involves drawing floor plan and sectional elevation of investigated buildings. Some photos are also taken for recording more detail information. The as-built floor plan includes the investigation of span length in between columns, dimension and location of column, masonry infill and RC wall. Sectional elevation has been drawn for location of doors and windows in masonry infill panel, floor height etc. Figure 6.17 showing some photos describing the preparation of as-built drawing of the building survey.

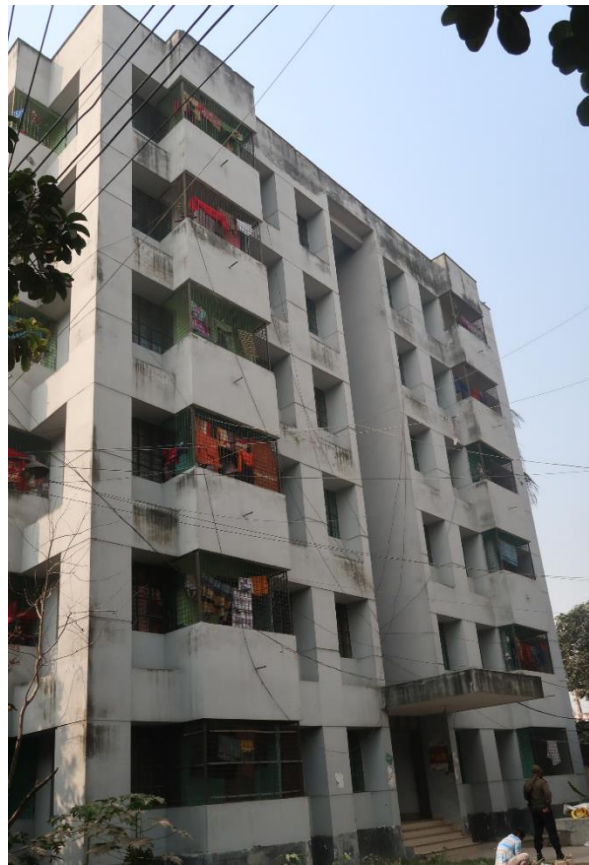
6.25 General view of the surveyed building no 3

An example of detail seismic evaluation has been described in following section. In this regard, buildings number 3 has been selected which is a 6 storied residential building as mentioned as staff quarter of medical college located at Dhaka. A general view is showing in Figure 6.25 describing outline of the building.

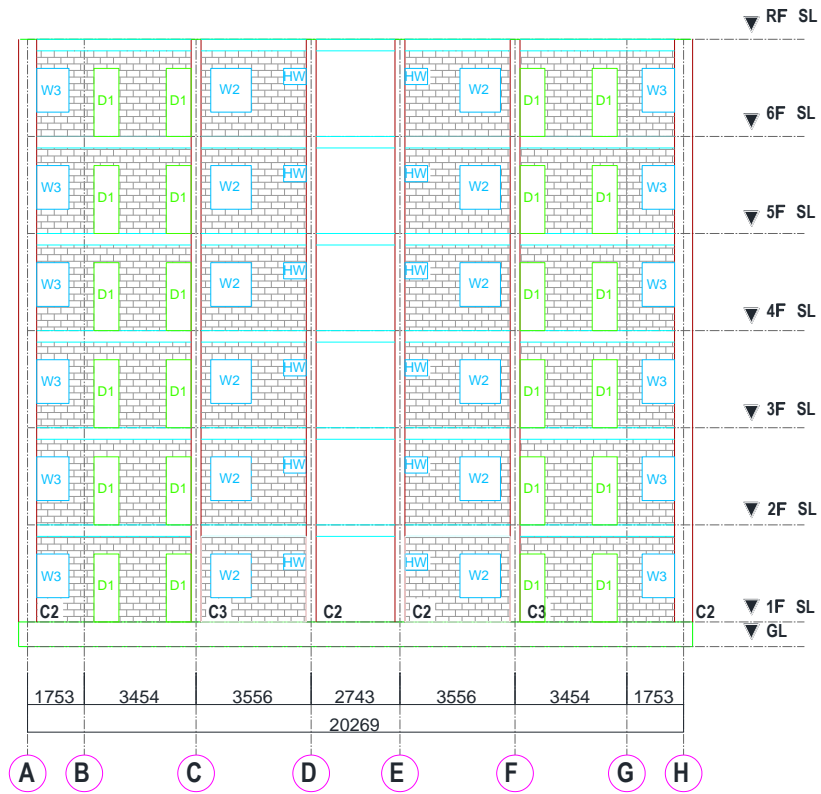
Figure: 6.29 Elevation at Frame 3 of building no. 3

Table 6.8 to Table 6.11 is showing the general information of the surveyed buildings. Figure 6.27 to 6.32 shows the elevation of the surveyed buildings. Location of doors and windows are shown in the Figures. However, the floor height is found as 3000mm. Figure 6.33 and 6.34 shows the dimension and reinforcement detail of column and beams of the investigated buildings.

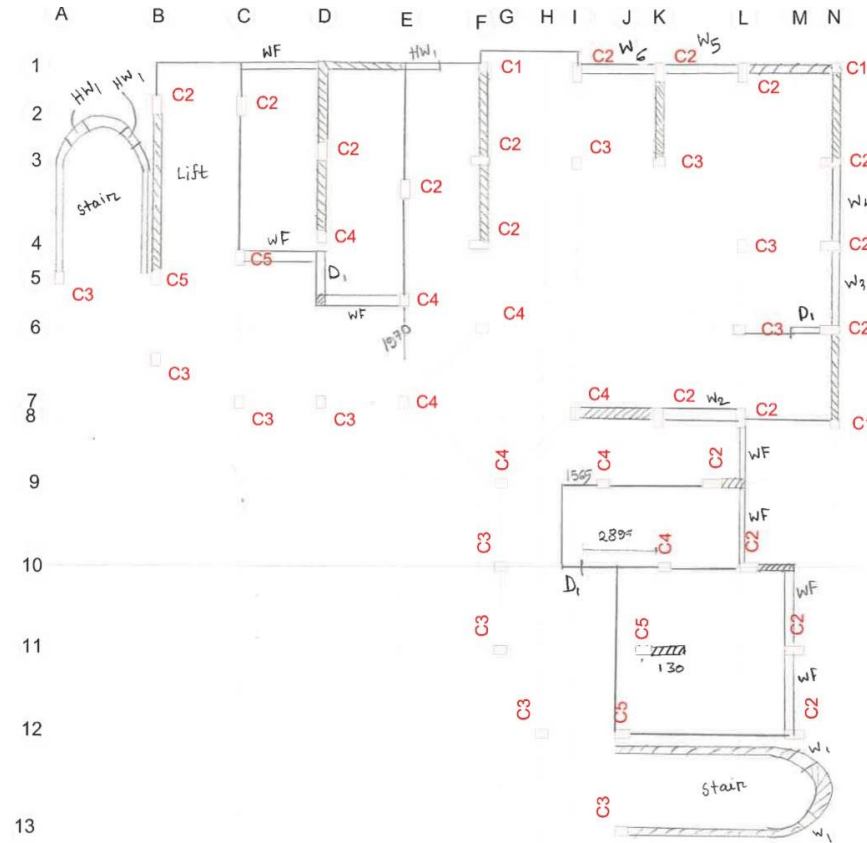
Architectural Plan

Dimension in inch. Feet (1 ft=30.48 cm, 1 inch=2.54 cm)
