Geomorphological Accidents caused by the Tokachi-oki Earthquake

Kasuke NISHIMURA, Shuryo SEGAWA, Hiroshi MIZUNO,
Hosei HOTTA, Osamu MIURA, Toshikazu TAMURA
and Takekazu AKAGIRI

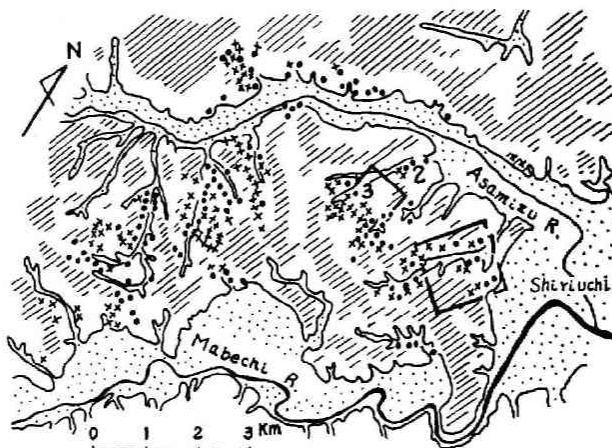
Fig. 3 Failed zones in the region to the west of Hachinohe
spot: failed zone with Scauper-type erosion area, cross: failed zone with Plane-type erosion area, hatch: upland surface, blank: valley wall, stipple: valley floor and the lowest terrace
Encircled areas with heavy lines are shown in Fig. 4.

Many slope failures by the Tokachi-oki earthquake in Hachinohe and around (Fig. 3) are not the rejuvenation of the former landslide areas subject to geological

structure such as the landslides observed at the Niigata earthquake (Nishimura *et al.* 1965) and as the landslides at this earthquake in Yamagata prefecture (Yonechi 1968). The sites of failures are not steep hillslopes but rather gentler slopes (5° at minimum). Collapsed materials of these failures are neither waste mantle nor bedrocks but younger pyroclastic fall deposits. The volume of the detritus is small (about $15,000 \text{ m}^3$ at maximum) but the distance of transport is relatively long (310 m at maximum).

Most of slope failures are concentrated in the valleys of small tributaries of the Asamizu river (west of Hachinohe) where there had been the heaviest rainfall amounting to 210 mm (observed at Gonohe) in preceding three days (Figs. 2 and 3). Each failed zone on the slope between the undulating upland surface and the narrow valley floor is composed of erosion area, runway through which detritus passed and deposition area (Figs. 4 and 5). The form of erosion area is apparently classified into Scauper and Plane types (Fig. 5, Photos. 1, 2).

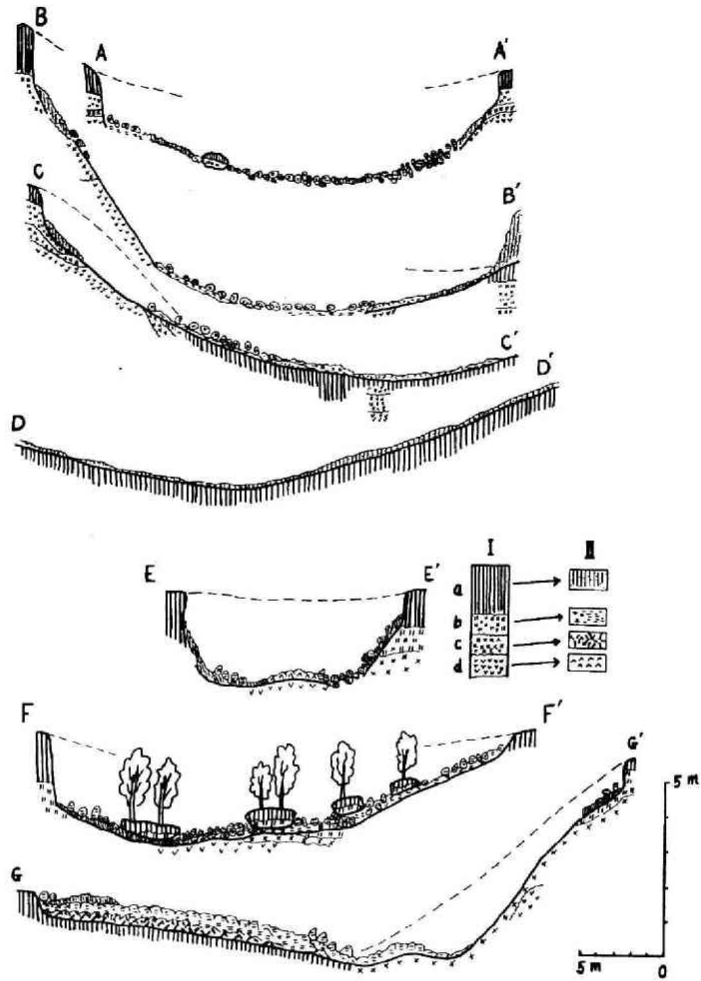
Fig. 6 Cross sections of the failed zones (Locs. 1 and 2)
 from A-A' to D-D': Loc. 1 from E-E' to G-G': Loc. 2 (see Fig. 5)

Stratigraphic sequence of surface materials less than 2 m in thickness are, upper to lower, black surface soil intercalating sandy pumice of Holocene, dark brown subsoil, yellowish brown clayey volcanic ash with yellow pumice grains of the latest Pleistocene, greyish white fine pumice of the latest Pleistocene and whitish coarse pumice of the latest Pleistocene (Fig. 6). Those materials except the coarse pumice were removed.

on the ground surface before the failure were mainly smashed materials of black surface soil and subsoil with blocks of yellowish brown volcanic ash removed from the erosion area (Fig. 6). Greyish white milky pumice was deposited directly on the original surface soil at some places of runway. Then it is suggested that this pumice removed at first from the erosion area. Deposits on runway were occasionally left at flow of materials from the erosion area to deposition area. The flow was very fast, seemingly 20 m/sec., an estimation based on several witnesses' observation.

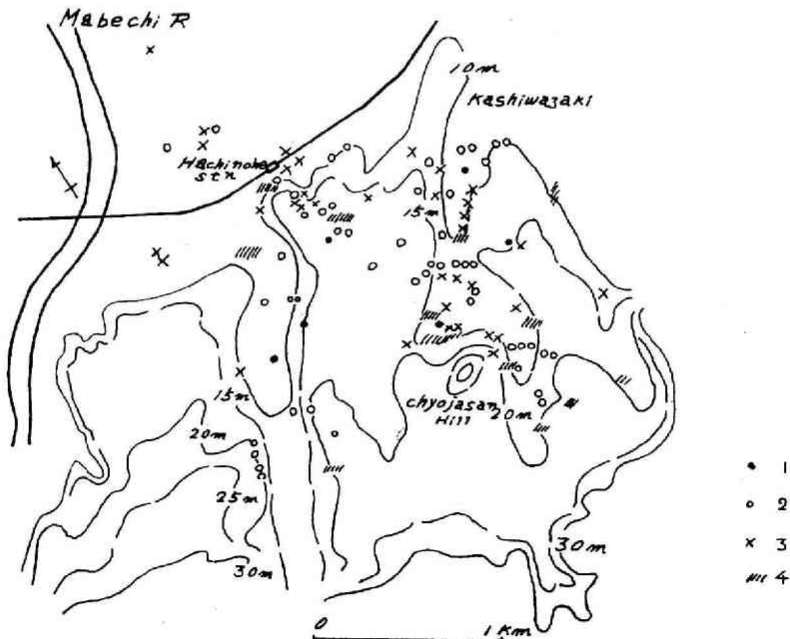
Fig. 14 Damages on the Hachinohe terrace

On the Hachinohe terrace (Fig. 14), where there is the urban center of Hachinohe city, the damage occurred selectively. Hachinohe terrace is covered with

thick volcanic ash and volcanic loamy ash (3–4 m in thickness), and underlying deposits are sand and gravel (2–3 m in thickness). The terrace surface is cut by open, shallow valleys which are also buried with the above mentioned volcanic ashes (Fig. 13), and the most damages occurred in these valleys. One runs from Kashiwazaki to Chojasan hill, and another runs just under the civic center where are located newly buildings and houses. Here, steel-concrete buildings, many houses, water pipes, and gas pipes suffered severe damages, because of the alluvial character in the buried valley areas and the insufficient condition of drainage. Out of these buried valley areas, at the smaller valleys and at the margin of the terrace, heavy damages occurred.
