## II. 2. Recovering Cyclotrons from the Great East Japan Earthquake

On March 11, 2011, the Great East Japan Earthquake struck the CYRIC<sup>1)</sup>. The accelerator facilities of CYRIC got serious damage. Afterwards, we put all of our effort into recovering the accelerator facilities. After the restoration activity was completed, the joint use of the accelerator facilities was re-started at October 2012. In this report, we describe briefly the damage and restoration activity of two cyclotrons and related equipment.

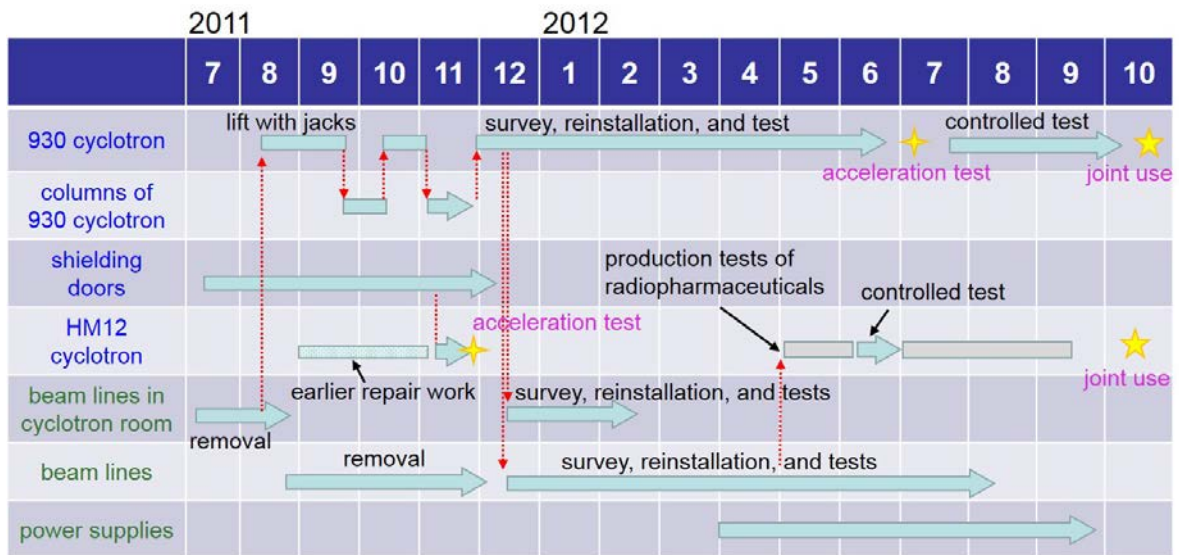
Figure 1. Outline process flow of the repair work.

Before the repair work, we have discussed the master plan for recovery. Figure 1

shows the outline process flow of the repair work. We planned to start by removing the beam lines from the cyclotron room to repair the columns of the 930 cyclotron. In parallel, our priority was to repair the shielding doors, because it was difficult to bring machinery in and out for the repair work. The restoration was started at June 2011, after the implementation of the first supplemental budget was enabled.
